American Granite Curb Producers

The American Granite Curb Producers announce the results of the most exhaustive tests and analyses ever performed, providing an unbiased comparison of the properties of granite and precast concrete curb.

GRANITE VS PRECAST CONCRETE

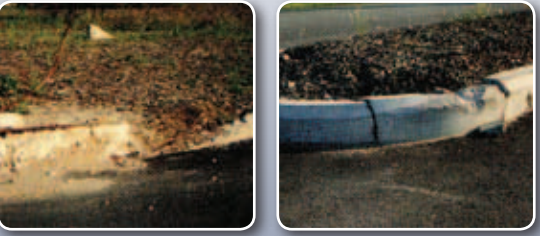
The effects of impact are obvious in these examples of precast curb installed less than three years ago.
